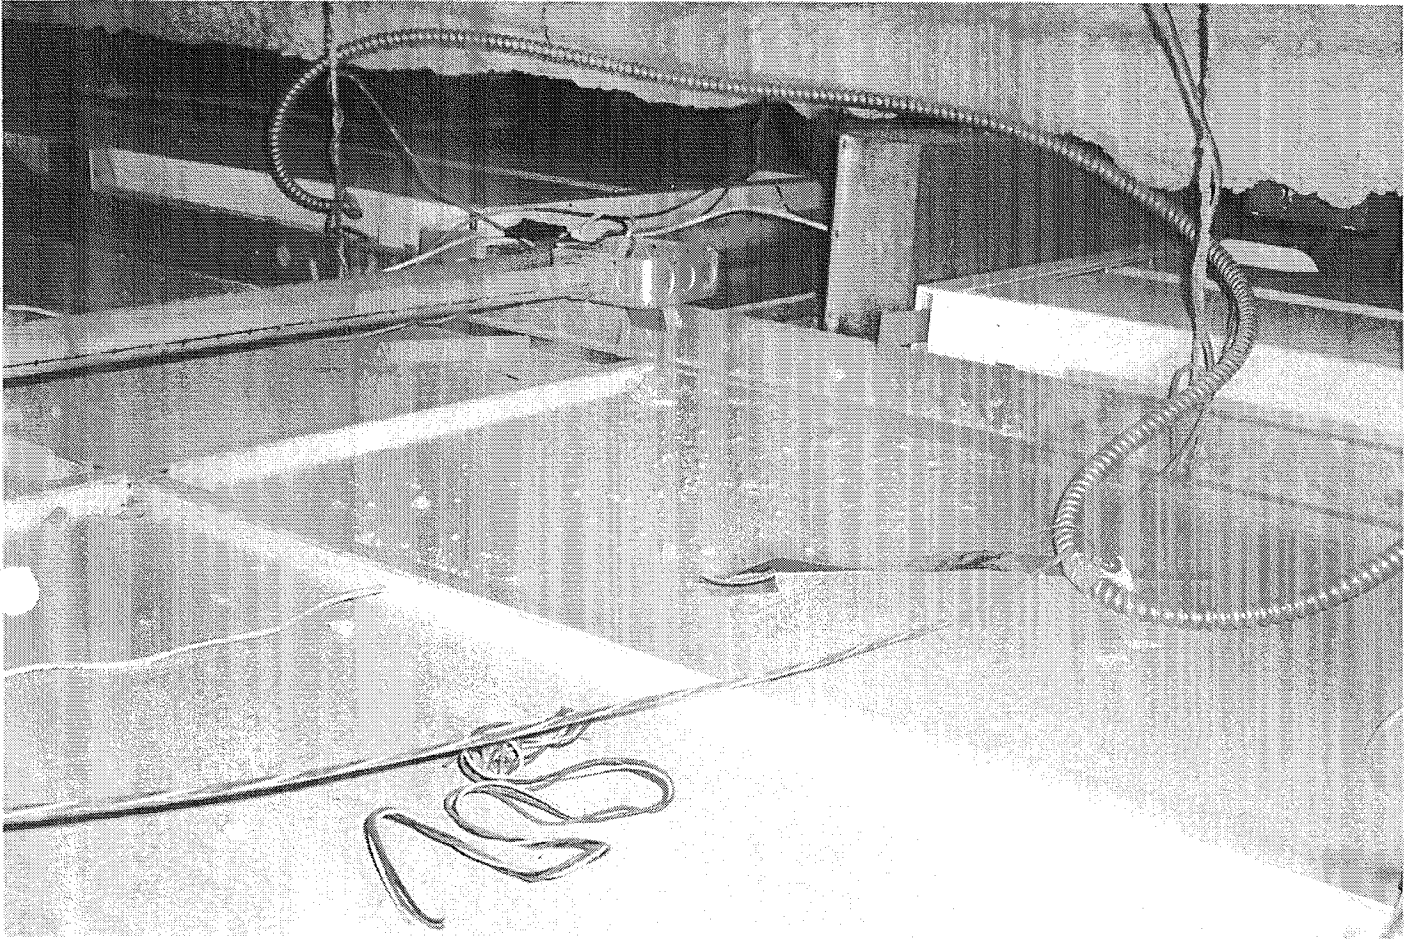
41. 12th floor, adjacent to room E1244A - View of delaminated fireproofing debris on top of suspended ceiling

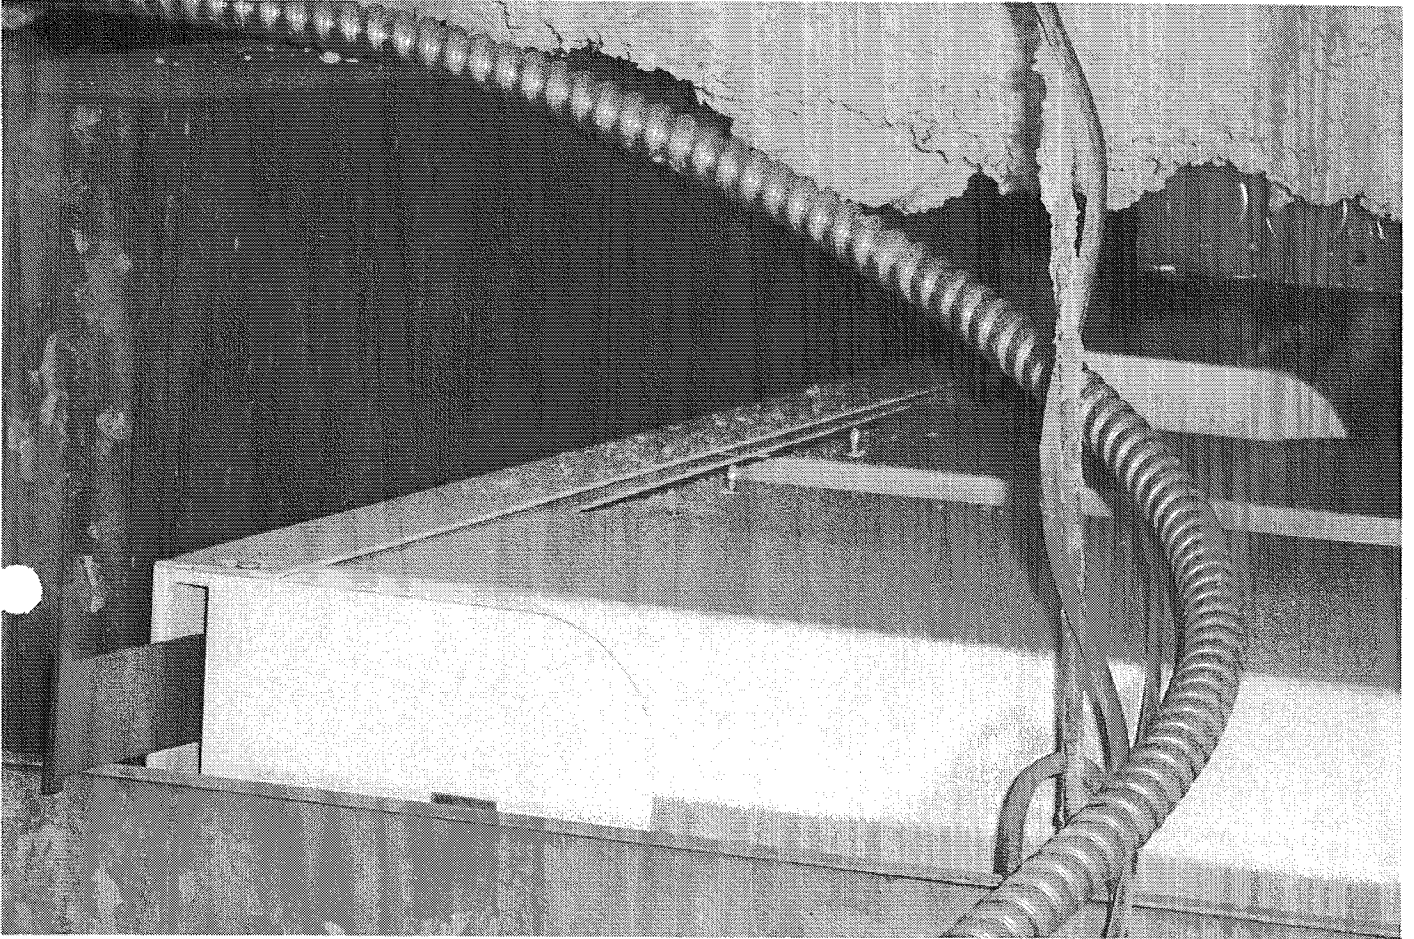
42. 12th floor, adjacent to room E1244A - General location of dust sample #5

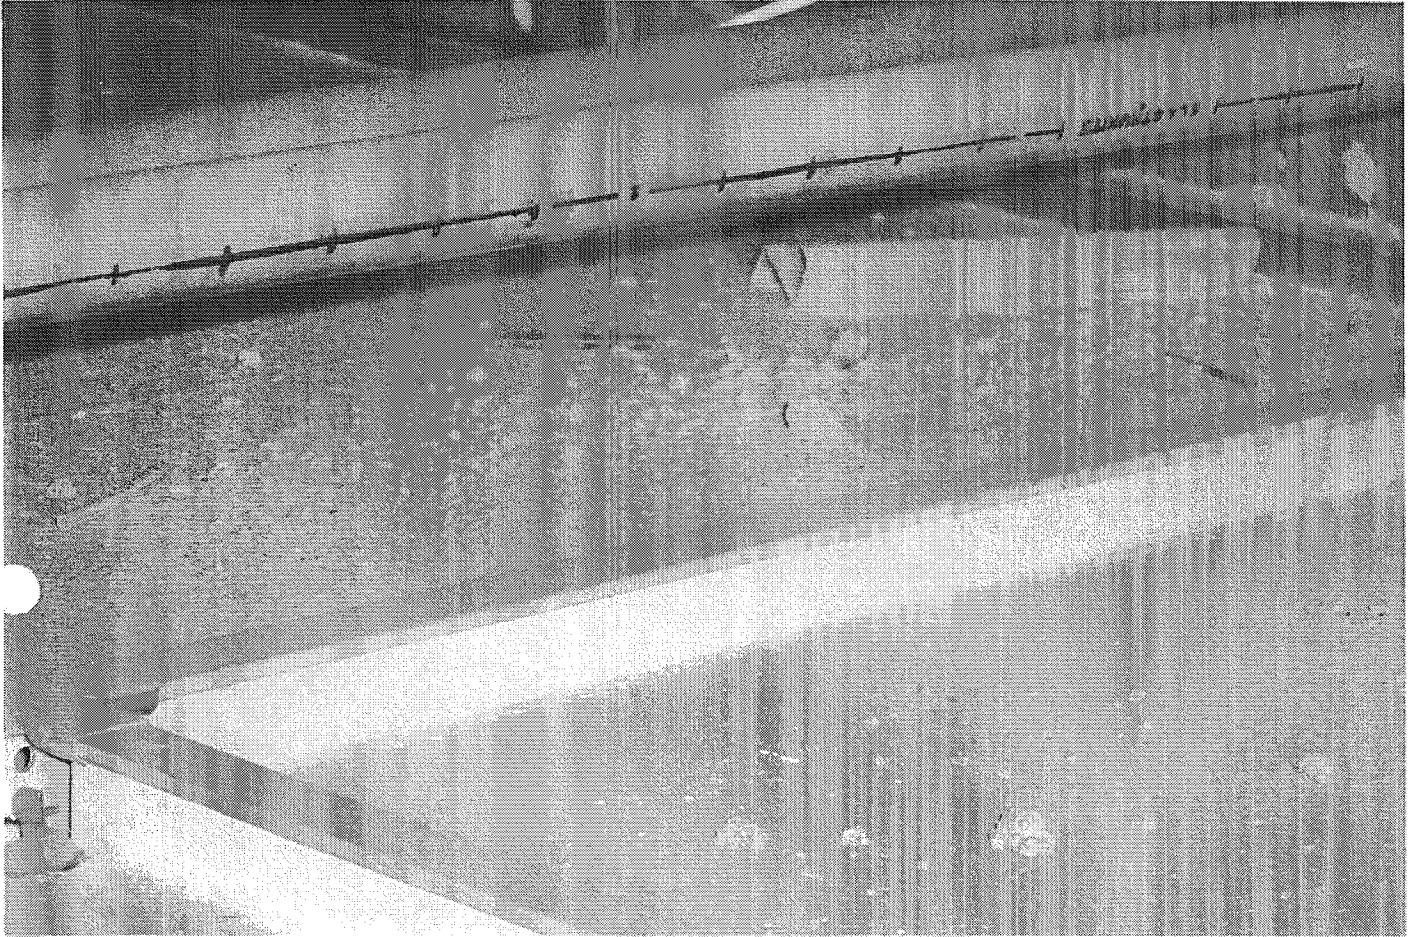
43. 12th floor, adjacent to room E1244A - Close-up of delaminated fireproofing debris on top of suspended ceiling

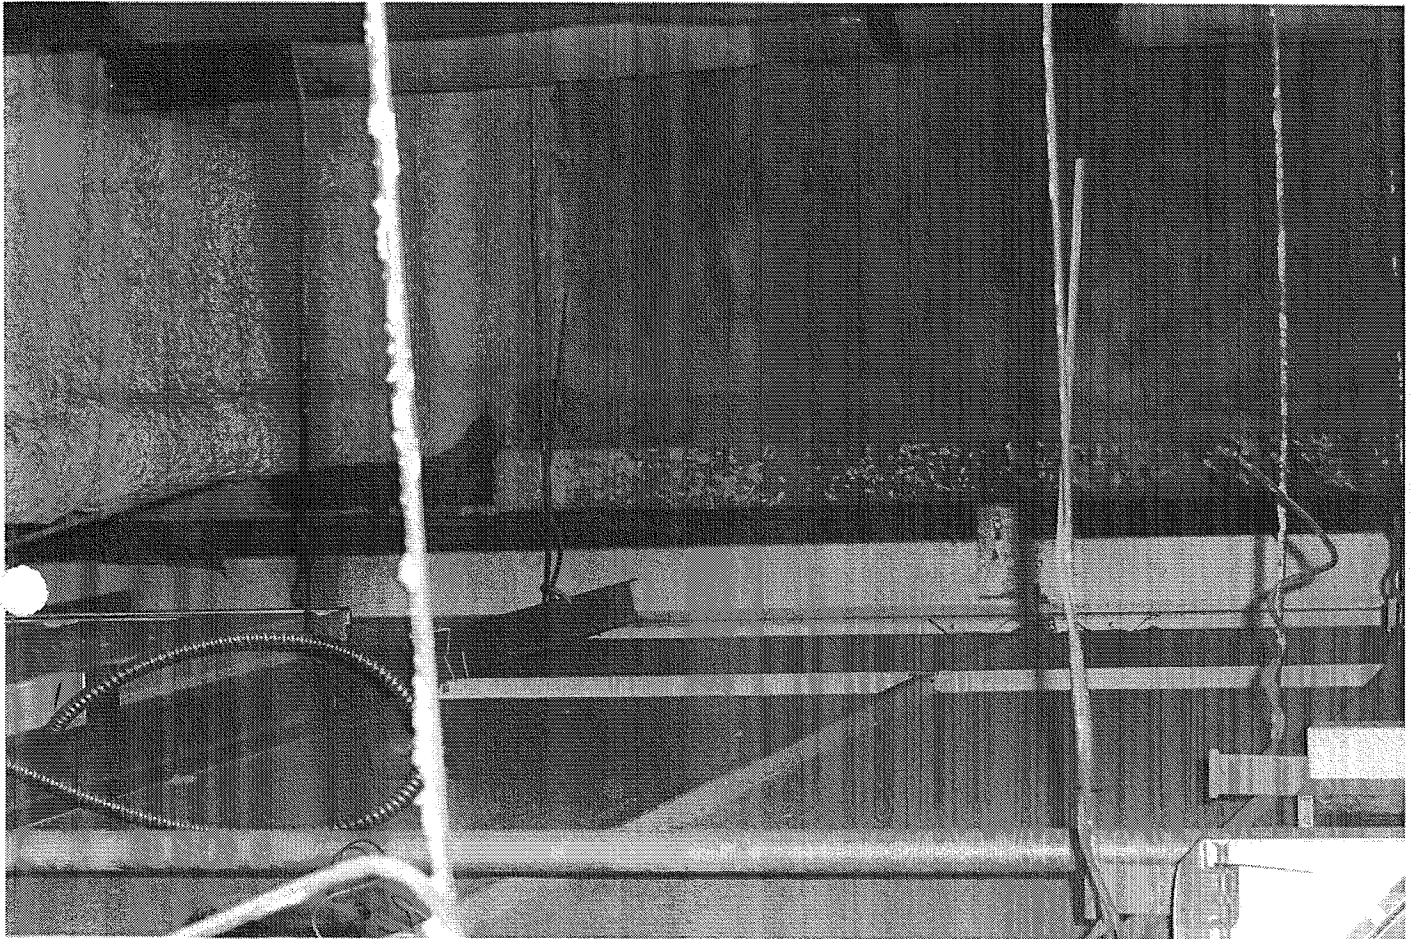
44. 12th floor, adjacent to room E1244A - View of fireproofing overspray on perimeter steel

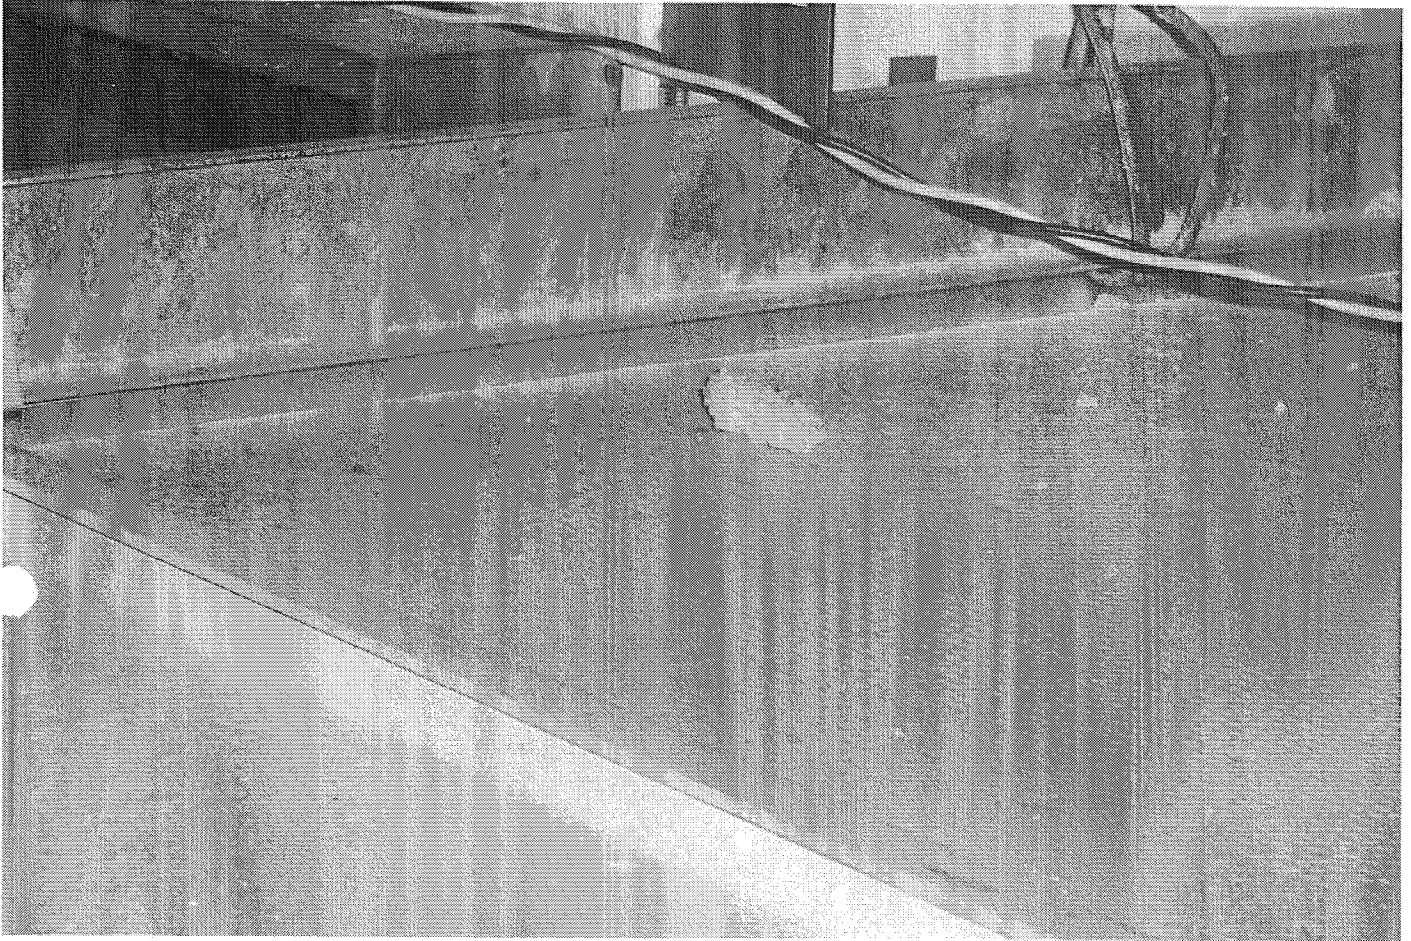
45. 12th floor, adjacent to room E1244A - Close-up of delaminated fireproofing debris on top of suspended ceiling
